SCOTT RIVER
CORRIDOR ENHANCEMENT PROJECT

A Final Report for Project # 95-HR-2119

Agreement # 14-48-0001-95625

Completed on January 31, 1997

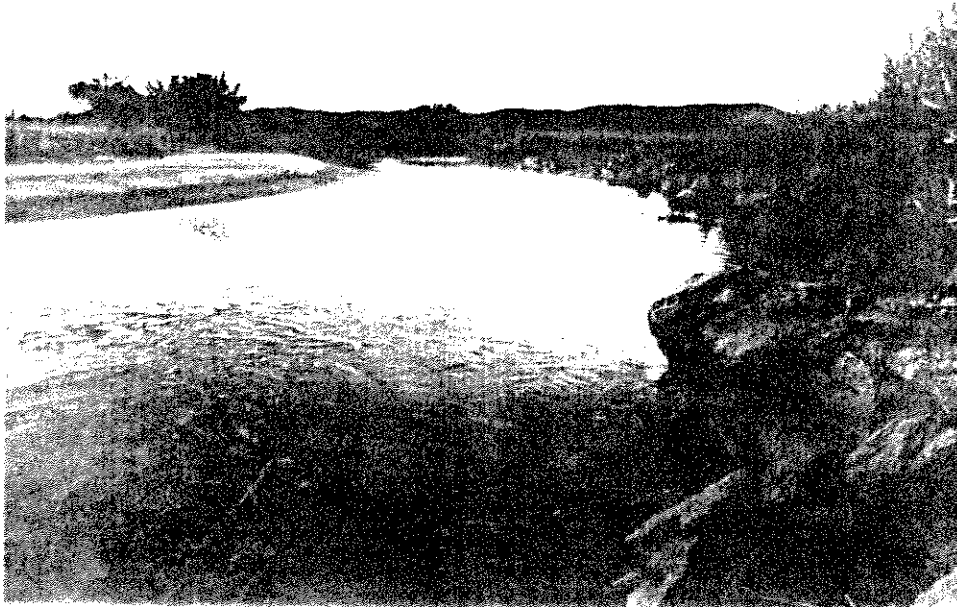
Figure 1. Typical deflector structures within the Eller Lane Project which includes the Hansen Property.

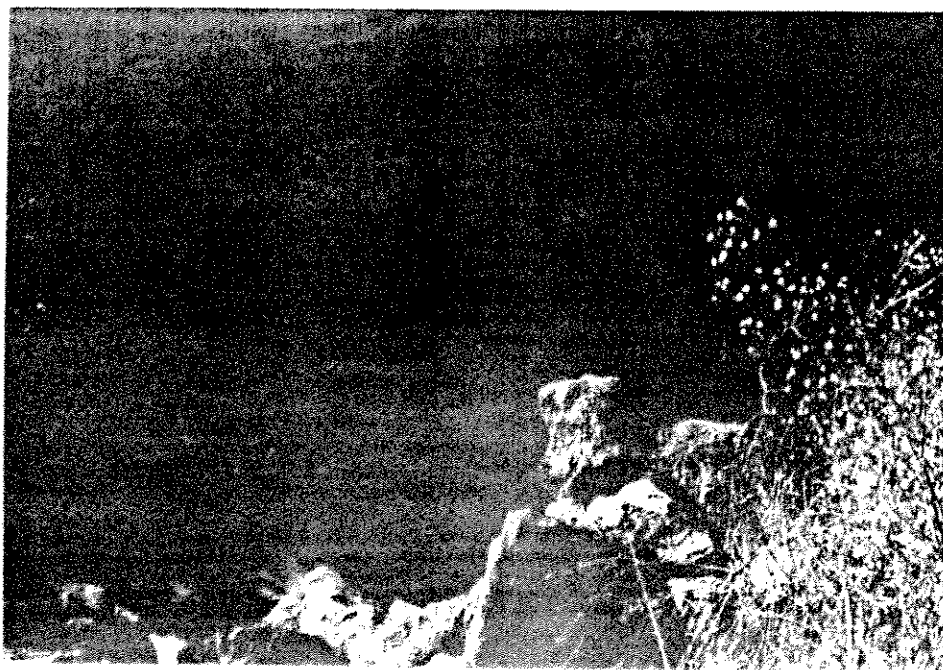
Figure 2. Structure within project site with adult chinook holding before moving upstream to spawn.

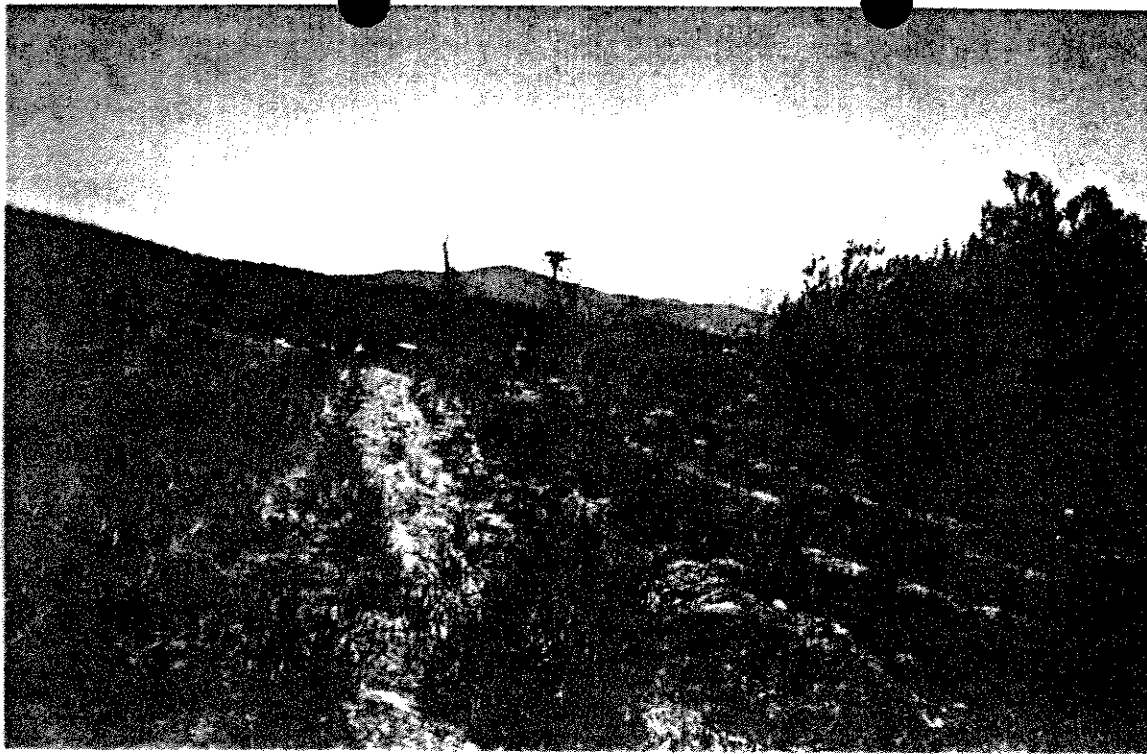
Figure 3. Riparian fencing and "silt baffle" layout on southern end of planting site.

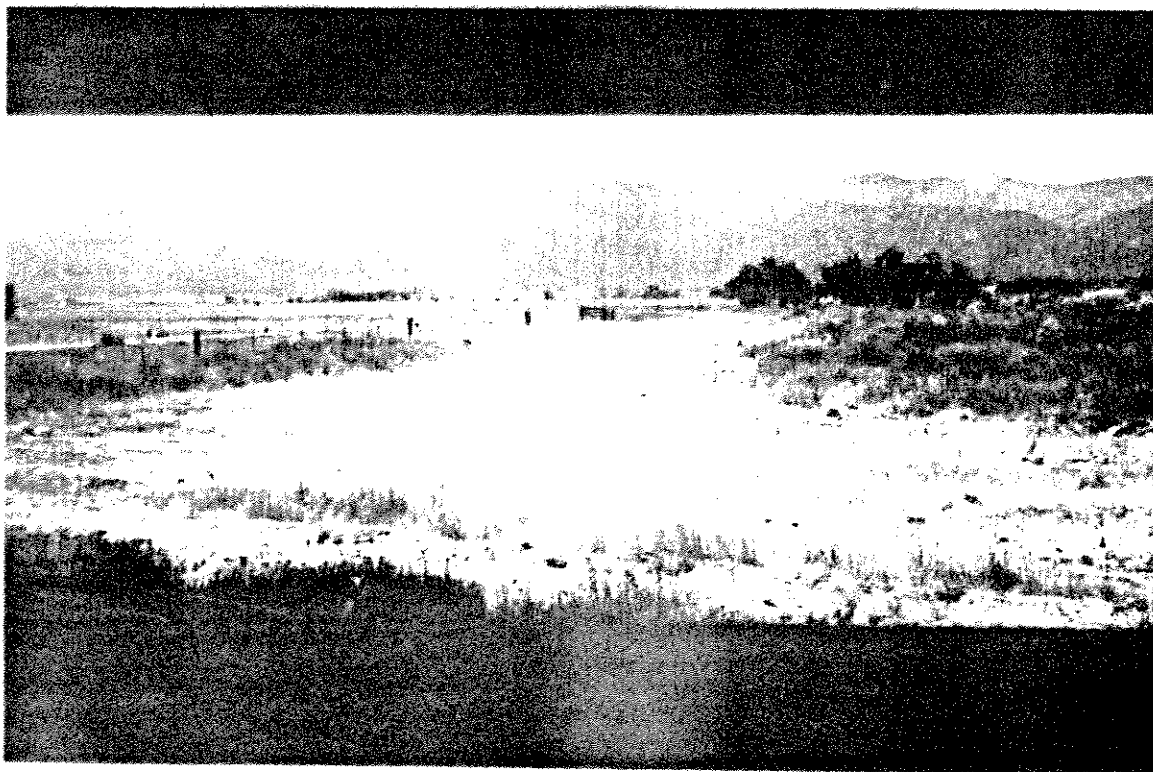
Figure 4 Large set aside area prepared for tree planting

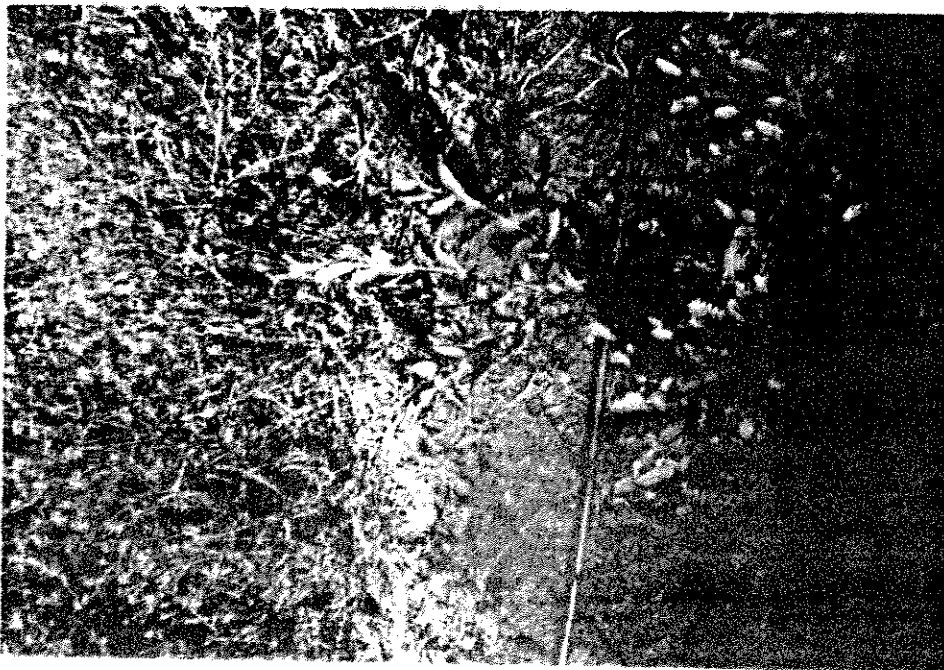
Figure 6. Cottonwood one month after planting. Note current species ^{of} ~~cover~~ ground cover is Yellow Star Thistle which is not shade tolerant.

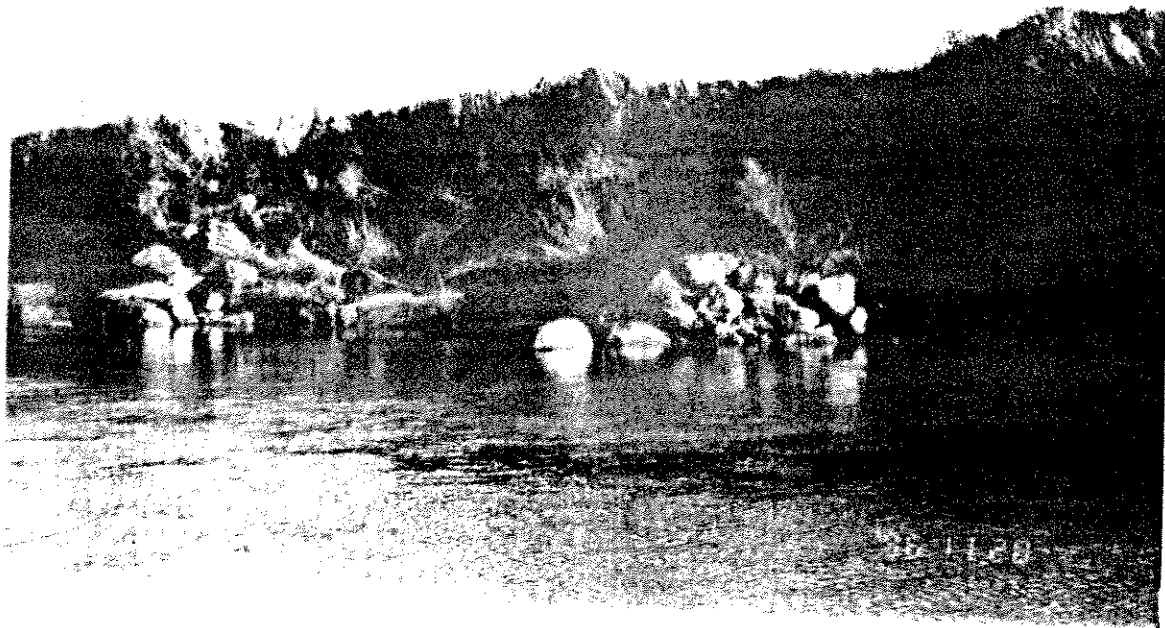
Before photo (above) and one year after project completion photo (below) of a segment within the Eller Lane project. Note: Bank was not mechanically laid back. The collection of silt built the bank up naturally. Revegetation strategy was to plant cottonwood and willow posts.

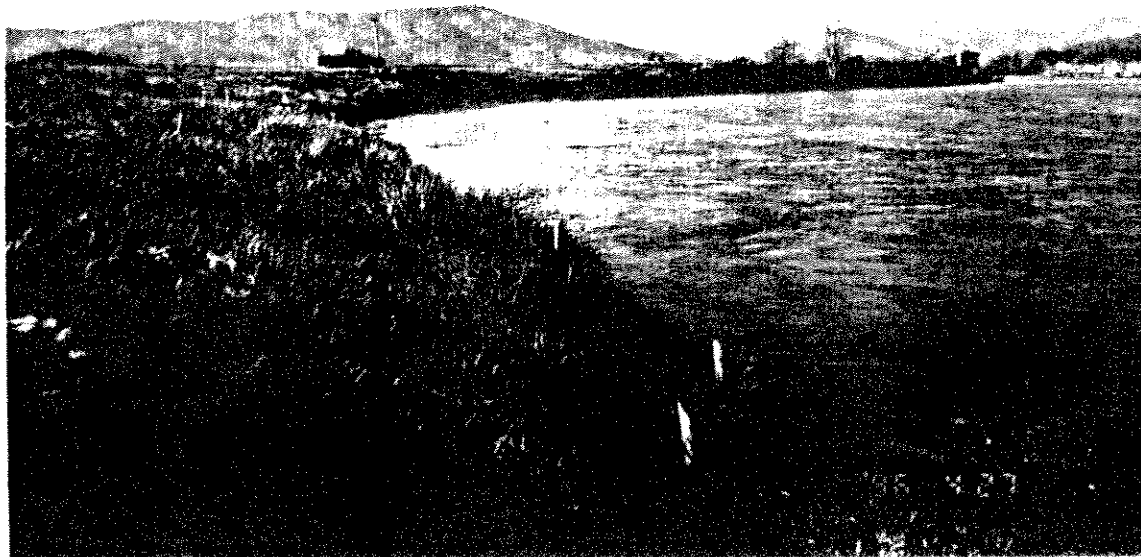
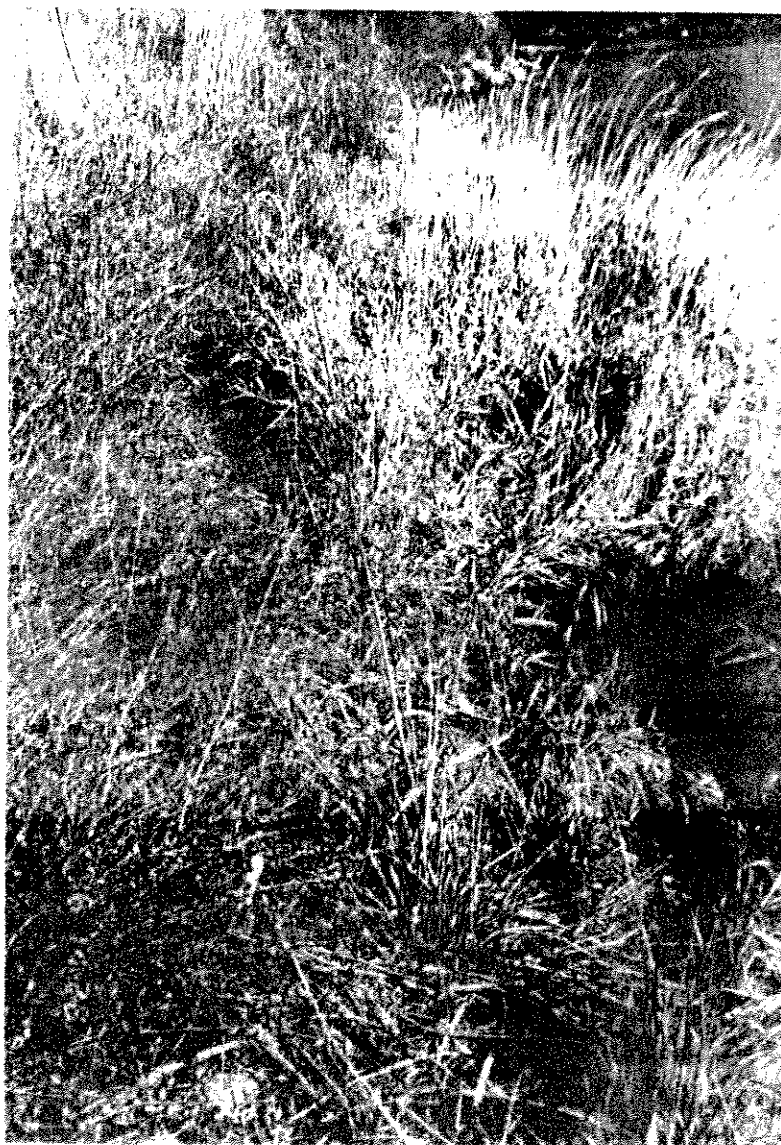
Above: Cotton wood and willow post planting demonstration within Eller Lane Project.
Below: Growth of willow post after one season.
